# Description and analysis of geotechnical aspects associated to the large 2010 Chile earthquake

Ramón Verdugo<sup>1</sup>, Felipe Villalobos<sup>2</sup>, Susumu Yasuda<sup>3</sup>, Kazuo Konagai<sup>4</sup>, Takahiro Sugano<sup>5</sup>, Mitsu Okamura<sup>6</sup>, Tetsuo Tobita<sup>7</sup> and Andrés Torres<sup>1</sup>

*A description of the strong 27 February 2010 seismic event occurred in centre and south of Chile is presented. Main geology and geotechnical conditions of selected sites are described. The study focuses mainly, but not only, on the liquefaction phenomenon which affected housing developments in Concepción, Hualpén and San Pedro de la Paz. The earthquake occurred at the end of the summer, therefore ground dry conditions prevailed. However, grounds near to water bodies were still saturated, mainly in places which were previously part of swamps and wetlands. In some of these places the replacement of soft and loose soils for compacted sand fills was not enough to avoid the occurrence of liquefaction. It is suggested to consider other techniques of soil improvement or deeper foundations when the subsoil has low shear strength and hence potentially liquefiable. An examp

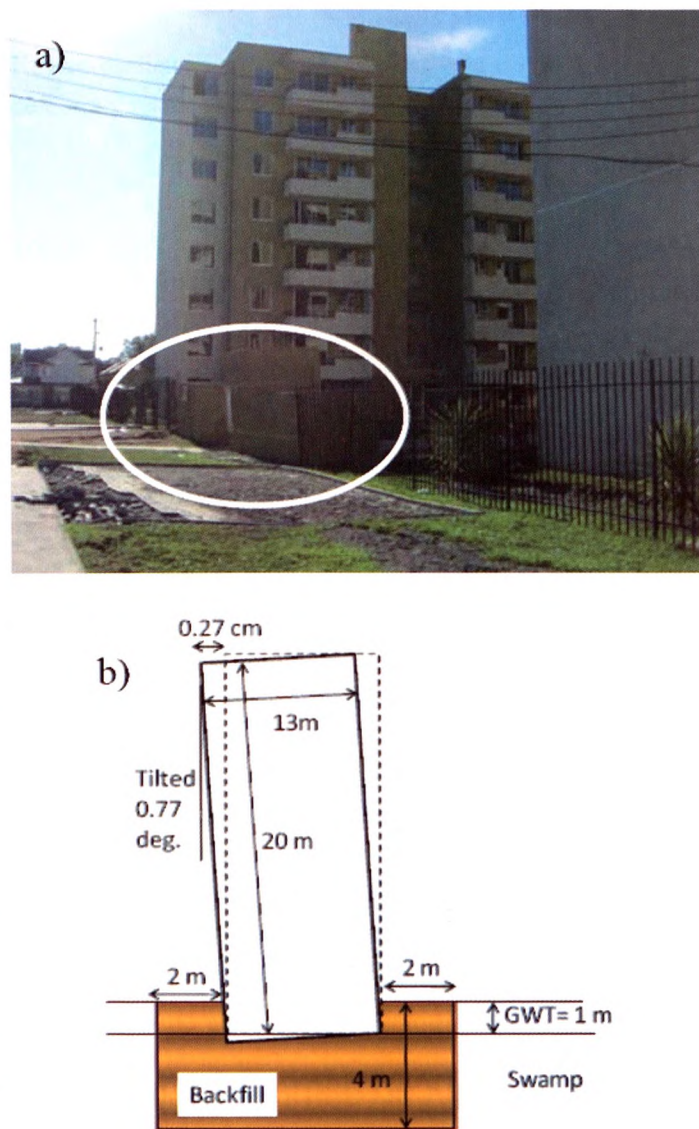
Figure 4a shows one of the four three-year-old apartment buildings of eight floors where liquefaction of the subsoil caused structural damage. It is possible to observe the tilted fence and booth at the entrance and material expelled by ejection from below the lawn and concrete blocks of the car park space. Evidence of sand boils was found around two

buildings, which verifies the occurrence of liquefaction. Figure 4b shows the inclination suffered by the building Riesco, which is estimated around  $0.77^\circ$ . GEER (2010) estimated a maximum settlement of 40 cm on one corner and 10 cm on the other extreme. The report released by GEER (2010) also gives information about the damage in structural elements of the building. According to construction information of the project a depth of ground water table of 1 m is considered for summer and a sand backfill of 4 m deep, in replacement of the original loose sandy and silty soil deposits belonging to a wetland, was recommended. The ground level is 15 masl, which is very low and can explain in part the wetland condition of the area. The ground formation is recent and involves mostly fine sand transported by the Bío Bío River in times when the river formed a delta flowing into the sea. The building foundation consists of shallow strip footings 1.2 m wide and 1 m deep. The soil replacement was not deep enough to countermeasure the highly likely occurrence of liquefaction. Analysis of SPT data, of the original project, indicates that below the soil replacement, *i.e.* from 4 m to 11 m, estimated relative densities were less than 60% and safety factors against liquefaction were less than 1 for the Riesco building. The building Errázuriz, in front of Riesco building, settled 10 cm and suffered damage in non structural elements.

Since there is no SPT data available for this building, it is believed that favourable variations in soil deposits may explain this situation. The other two buildings, Bulnes and Montt did not suffer considerable structural damage and people are again living there. In the Montt building site a borehole data was available whereby relative densities were found higher than 60% between 4 m and 11 m and the safety factor against liquefaction was found higher than 1, except between 5.5 m and 7.5 m. This assessment is in agreement with the liquefaction evaluation following the procedure by Seed and Idriss (1971) based on the interpretation of SPT tests and soil mechanics data (see also Kramer 1996).

Figure 4: Building Riesco at Los Presidentes a) granular material on the lawn and on a concrete block surface as a result of liquefaction and b) schematic cross section showing tilting of the building Riesco.

Possible thoughts about the foundation design of the buildings may include the use of deep foundations. The election of a piled foundation does not avoid *per se* the occurrence of liquefaction and therefore requires also a careful design. Probably the use of basements together with deeper soil improvement techniques may be a good option. Gravel columns, cement or slime injection can be

considered as possible ground improvement techniques to choose from. In any situation it is compulsory to carry out a more detailed soil exploration and geotechnical laboratory and desk studies, which includes deeper soil deposits, beyond 11 m.

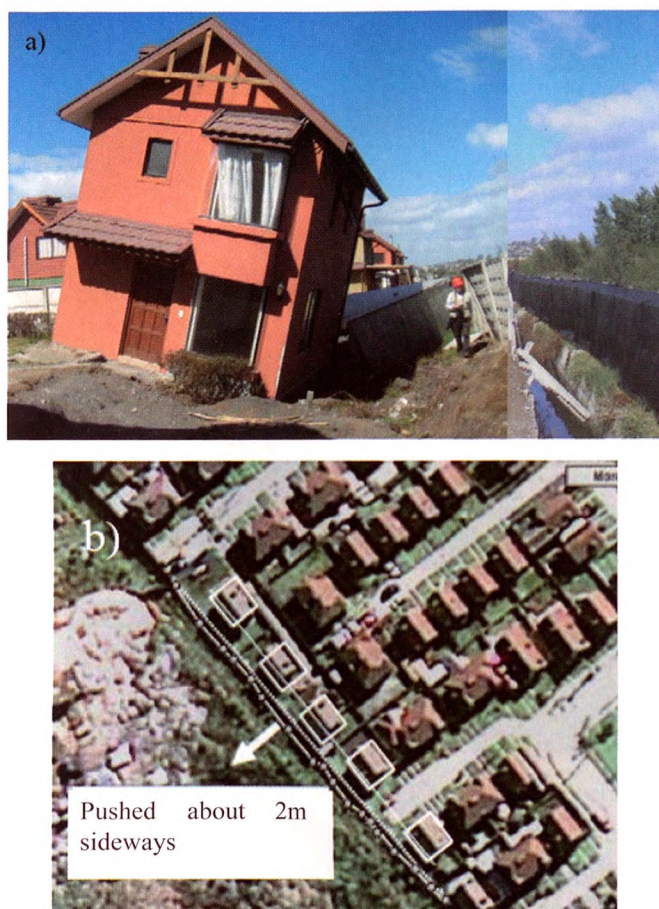
At Brisa del Sol a couple of less than one year old houses located along the border of a canal suffered serious lateral displacement and rotation. Figure 5a shows the significant rotation of a house as a result of lateral movement of the foundation soil. Seismic forces caused the soil to displace around 2 m, as depicted in Figure 5b, which left houses without support, in other words soil foundation was removed. The ground is similar to that described for Los

Presidentes buildings, *i.e.* loose and soft soil deposits as part of a wetland. On the other side of the canal the land is covered by green vegetation due to shallow water table (Figure 5a). The ground improvement technique worked well for the majority of the housing development except for this border next to a canal. The 2 and 3 m of compacted sand used as a fill did not have more lateral restraint than a 2.5 m high narrow stone block wall which forms one of the canal side. In view of these evidences, it is not recommended to build a structure close to a border which does not have firm restrains to lateral movements. There are many types of retaining structures to support an embankment such as reinforced concrete, earth reinforced or anchored walls.

Figure 5: Houses at Brisa del Sol a) significantly tilted house and b) line of houses affected by ground lateral displacement

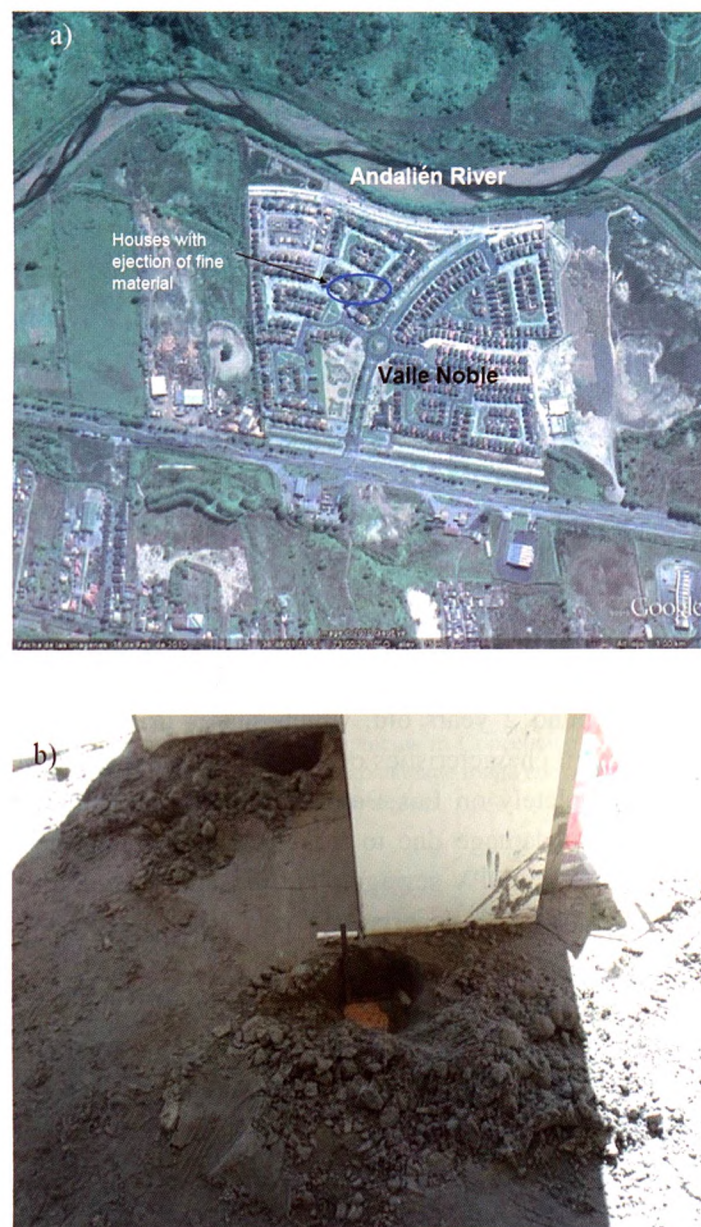
Valle Noble is a relatively new group of houses located on a reclaimed floodable area of the Andalién River. To avoid flooding houses were built on top of approximately 3 m high fill soil, mostly sand although is also possible to find finer material. Only in a few houses strong ejection of fine

material occurred in the garden and two houses ejection took place also inside the house. It is not known whether gaps between walls and floor slab already existed or elevated excess pore water pressure broke through. The river presence indicates that the water table is relatively superficial even during dry season. But the question is why this occurred only in a few houses. It is probable that the presence of a perched water table in this site together with the presence of a low permeability material, did not allow adequate dissipation of excess pore water pressure.

Figure 6: Valle Noble a) location of affected houses and b) large amount of fine material ejected inside a house up to 10cm thickness

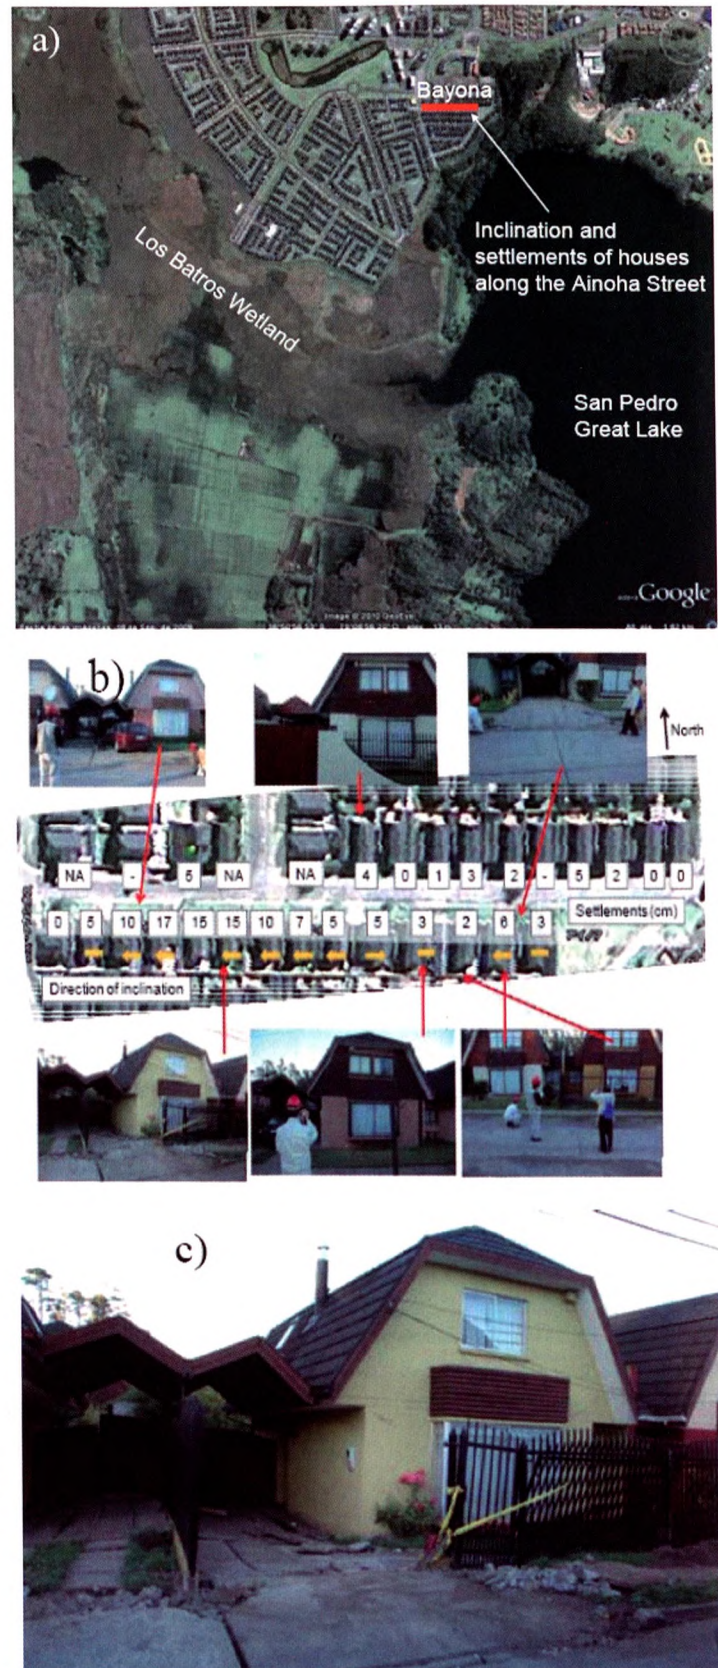
San Pedro de la Paz is a town on the other side of the Bío Bío River. Around hundred thousand people live over there as a consequence of continuous constructions of housing developments. In San Pedro de la Paz soil deposits are mostly composed of loose to medium sand transported in the past by the Bío Bío River. However, there are also residual soils as a result of weathering of metamorphic rocks as part of hills and there are also organic and soft soils in low land areas belonging to wetlands. Figure 7a shows that Bayona, group of houses built in the early 90s, is located in the transition between residual soils on the lap of a hill and the former location of the wetland Los Batros. For the house construction, shallower soft and organic soils were replaced by compacted sand. However, this superficial improvement technique was not enough to avoid the occurrence of liquefaction in Ainoha Street shown in Figure 7b, where settlements in cm and direction of house rotation are shown. Figure 7c shows the case of a house with a subsidence of 15 cm. It is worth mentioning that settlements were not uniform and more pronounced under the house strip footing foundations, which resulted in the bulging of the house inside floor slab, breaking the slab and the covering of the floor. Pavement concrete blocks in the house entrances were also twisted and broken. Moreover, ejected fine soil was observed as a proof of liquefaction.

Figure 7: Bayona houses in San Pedro de la Paz: a) aerial view showing proximity to a lake and a wetland, b) measurements of settlements and c) house with a subsidence of around 15 cm

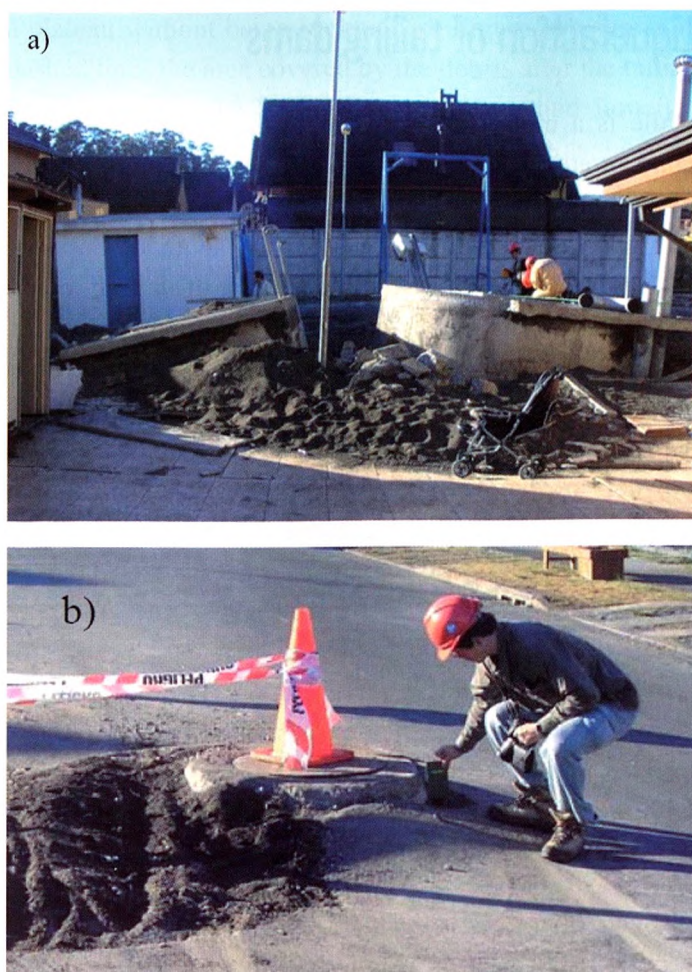
San Pedro del Valle (SPV) is a much more recent group of houses, around 2 years old, which shares practically the same subsoil characteristics of Bayona. Although SPV is almost completely on Los Batros wetland, only some houses suffered damage due to liquefaction (not shown here). However, the SPV sewage plant in Laguna Grande Avenue was found with important damage caused by what is called floating of buried structures. Sewage tanks were uplifted from their original positions in a very spectacular way as shown in Figure 8a. Two tanks buried approximately 2,5 m and 5 m deep rotated when uplifted around 1.2 m, breaking the steel pipe which connected them. Not well compacted sand used as a fill after excavating for the tank construction liquefied and caused the uplift of the buried tanks.

In addition, manhole uplifts up to 30 cm were observed in the middle and along of Laguna Grande Avenue. Figure 8b shows an example of an uplifted manhole. In general, this

phenomenon is not taken into account in the design of sewage systems, hence further research in this topic is needed.

Figure 8: a) Uplift of buried sewage tanks in San Pedro del Valle and b) manhole uplifted

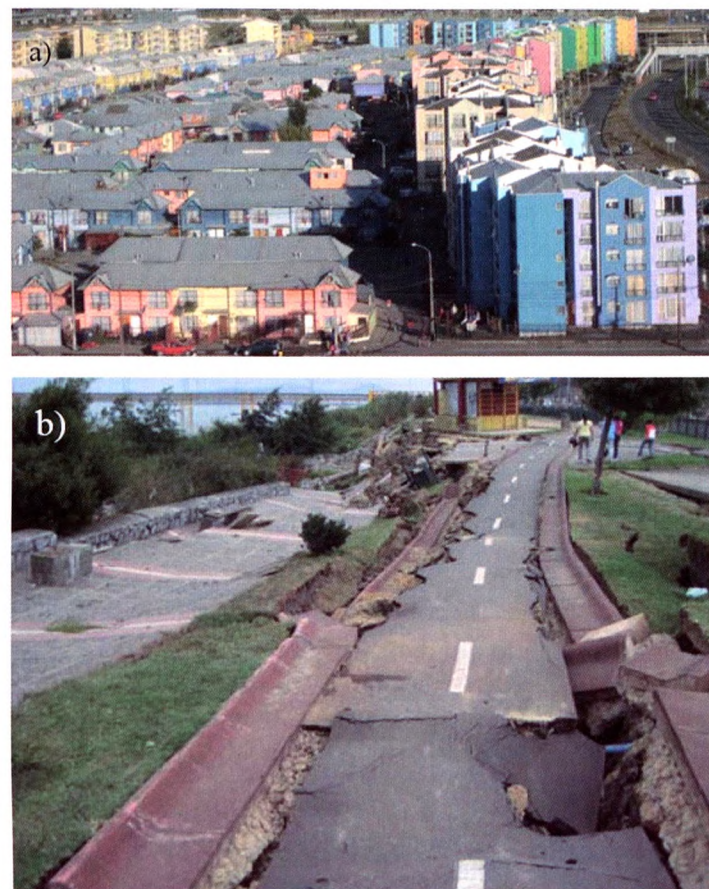
It is important to highlight the well performance against the earthquake of a housing development project where dynamic compaction was used as a ground improvement technique. The project Ribera Norte Bío Bío was carried out in 1998 and 1999 with the purpose of reclaiming 10 hectares of a flood swamp area close to the centre of Concepción and next to Bío Bío River North Bank. The project was initially studied by Poblete (1997), who proposed a grid with the sequence of impacts of a mass of 15 tons and 10 m of drop height. The project was subsequently performed by the consulting company Geotécnica Consultores, who based the soil improvement study on analyses of liquefaction potential of the replaced soil as well as the underlying soils (Verdugo, 1998). The sand replaced and used as a fill had 6 m thickness and the effect of densification is estimated to improve at least 10 m deep. To verify the dynamic compaction results a series of SPT tests were carried out before, during and after the dynamic compaction. The criterion was that no

liquefaction of the subsoil should occur even under strong earthquakes. It is worth pointing out that the promenade between the motorway and the Bío Bío River, where soil was not dynamically compacted, suffered considerable lateral spreading due to liquefaction, destroying pedestrian pavements, cycle paths, gardens, small shops, *etc.* (see Figures 9a and 9b).

Figure 9: a) Housing developments in Concepción built on densified soil by dynamic compaction, no damage found and b) crossing the road, lateral spreading destroyed promenade

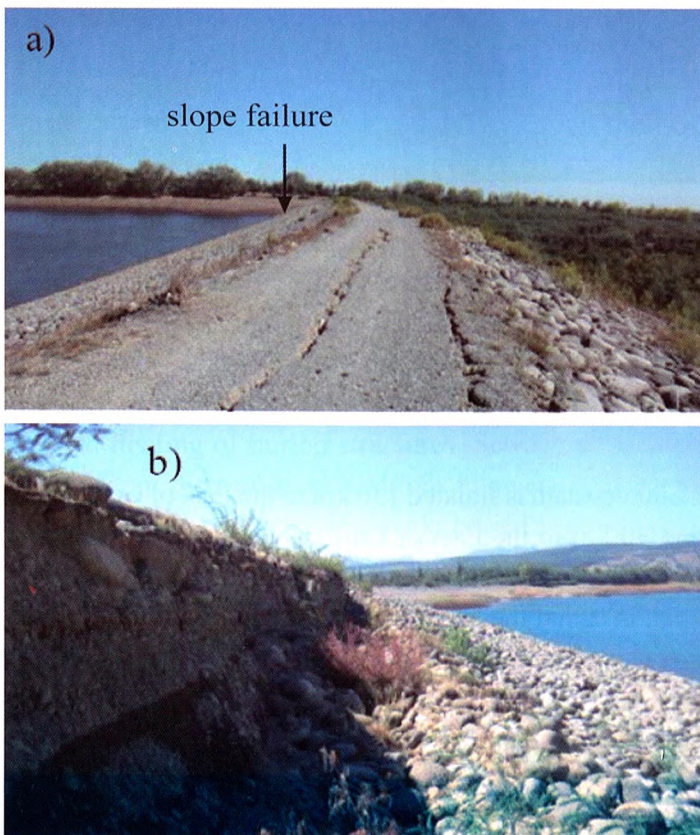
2.26 million m<sup>2</sup>. Since the earthquake occurred at the end of the dry season the reservoir water level was around 12 m lower than during winter. The dam suffered localised evidences of damage such as cracks and slides of dam material. Figure 10a shows two longitudinal cracks along the 5.2 m wide crest of the dam; one in the centre and the other one on the downstream shoulder side. The depth of the centre crack reached a maximum of 1.9 m, close to where the largest movement of the dam was found. This is shown in Figure 10b, where it can be observed the shoulder downward slip movement of the slope on the reservoir side, which extended for approximately 100 m. This movement resulted in a maximum subsidence of 3.3 m near the crest and an average horizontal displacement of 1.3 m extending to the toe. In Figure 10b it can be also observed the presence of gravel on top followed by a wet fine material corresponding to the impervious core. A possible hypothesis is that the slope failure mechanism involves the sliding of the shoulder made up of dry gravel over the impervious wet core material, which acted as a lubricated sliding surface. The question is why this occurred only in this section of the dam and did not propagate further. It is believed that humidity was kept because of the proximity of the dam buttress, where it can be seen in Figure 10a predominance of vegetation.

Figure 10: Coihueco dam a) longitudinal cracks at the dam crest and b) downwards movement of the upstream slope

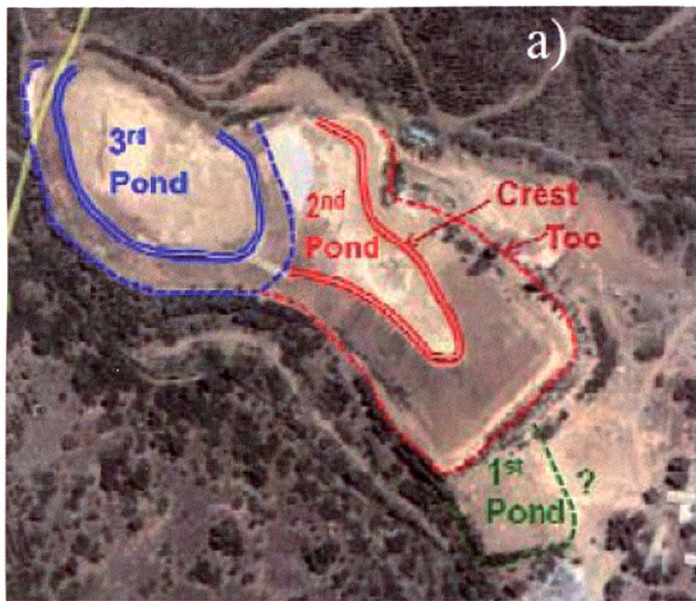
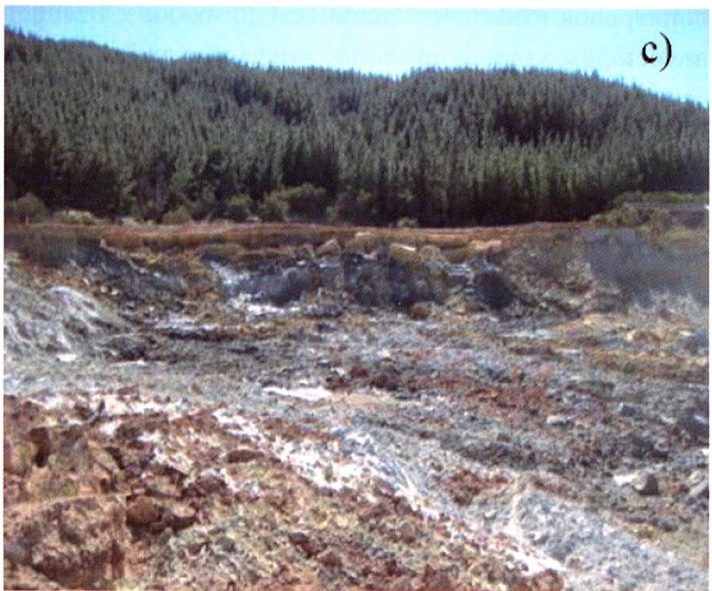
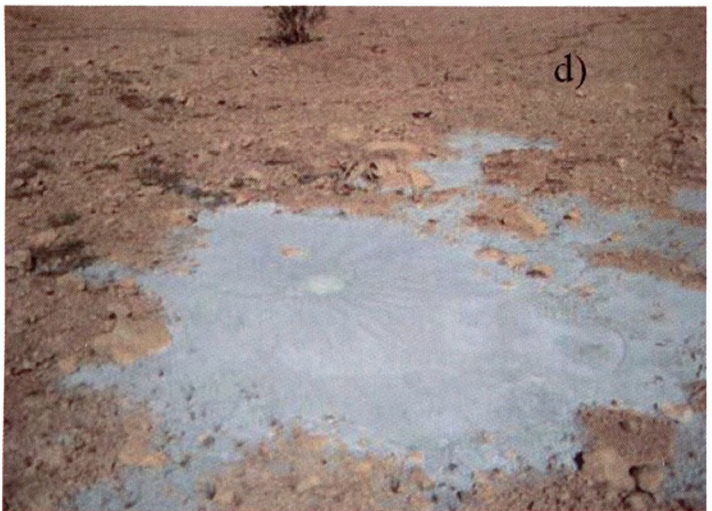
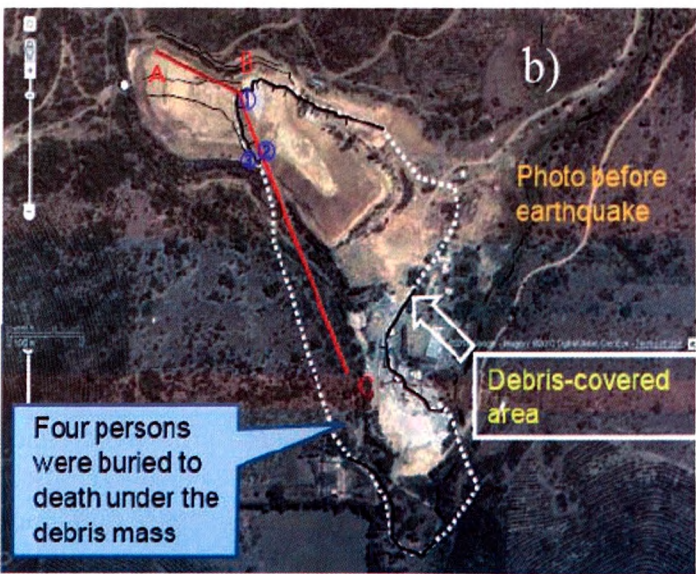
Liquefaction of mine tailings occurred at Las Palmas, Veta del Agua, and La Florida. The authors were able to inspect the significant damage at Las Palmas, near the city of Curicó. Las Palmas is located in the coastal mountain chain of central Chile. This tailing reservoir was used as a deposit of gold mine waste between the years 1981 and 1997. Figure 11a shows an aerial view of the abandoned Las Palmas tailing dam where it can be observed that it is not really clear whether there was or not a dam or a wall to retain the tailings. It seems that ponds were extended forward as

a plateau without being impounded. Figure 11b shows in dashed lines the area covered by the debris after the tailing flow failure shown in Figure 11c. Water and liquefied tailings erupted from many cracks at the surface as shown in Figure 11d. Hundreds of little volcanoes could be still seen over the debris, indicating that once the material flowed and rested in a new lower position, liquefaction occurred again because excess pore water pressure accumulated due to aftershocks. The liquefied mine tailings flowed down about 400 m and hit a farmer's house, killing four people who were buried to death under the tailing mass (Figure 11b).

Figure 11: Las Palmas tailing dam: c) debris flow and d) isolated volcano on a pond

Figure 11: Las Palmas tailing dam: a) arrangement, b) geometry of the debris covered area and c) debris flow

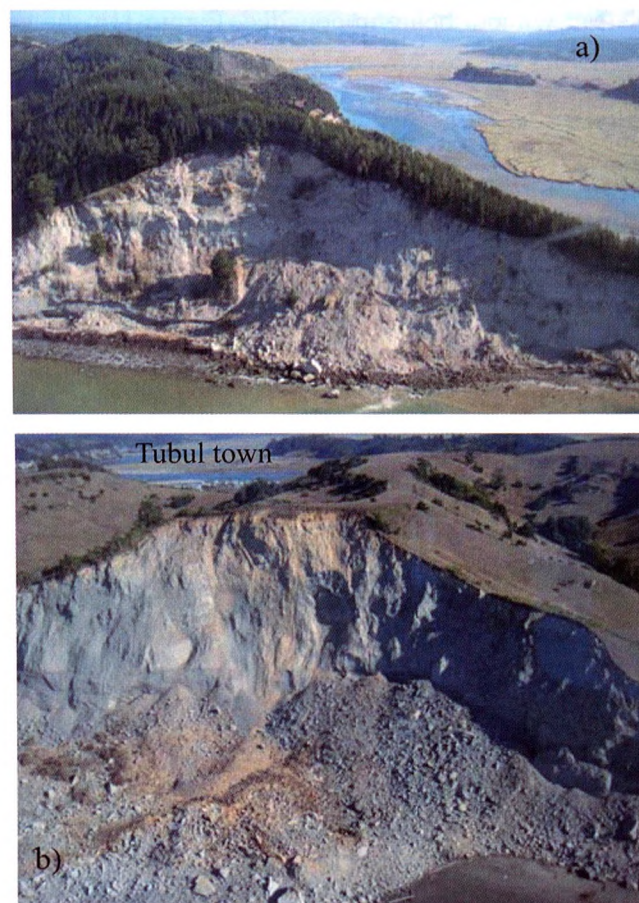
corresponds to different geological formations, but they are composed mainly of marine sandstones and siltstones. Figure 13a shows a landslide of the Navidad formation just at the entrance of the Raqui wetland (seen behind). The ground on the shore is made up of marine terrace sediments and in the wetland the material corresponds to a very soft organic peat. Figure 13b shows a landslide in the Tubul formation with a view behind of part of the Raqui wetland and the town of Tubul. In both landslides the failure surface is very steep with the material falling over the beach. It is important to know that, for this earthquake, the Arauco Peninsula is located approximately in the further South part of the Nazca plate section which dipped under the South America plate. In other words, the further South aftershocks recorded were around this peninsula (Barrientos 2010). Moreover, large tectonic movements have been measured by GPS instruments and by visual observations. For example, in Concepción (50 km north from Arauco city) horizontal displacements between 3 and 4 m and uplifts in Punta Lavapié of around 2 m have been estimated (Barrientos 2010). It is believed that landslides were triggered not only by the strong cyclic motion but also by the lateral (towards the trench) and vertical (uplift) displacements of the earth crust. Further research is needed to understand the effect of coupling of this complex shaken plus pushing and uplifting on seismic slope stability.

Figure 13: Landslides in coastal cliffs a) from the north and b) from the south of Tubul

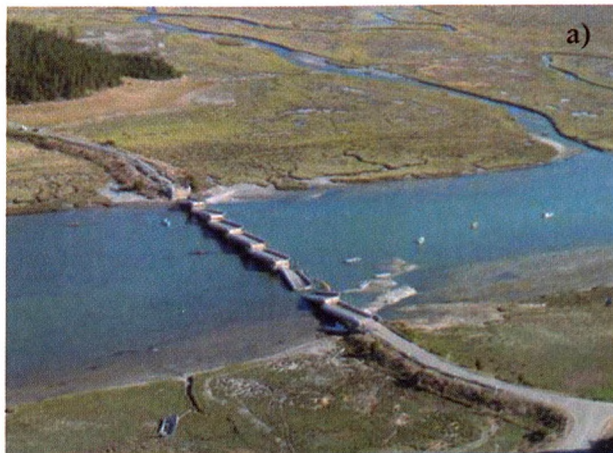
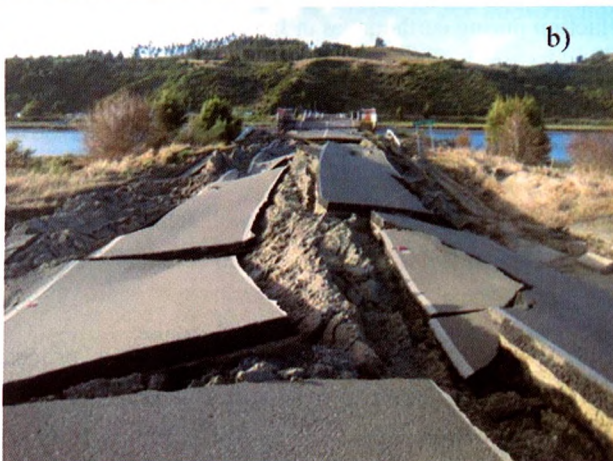
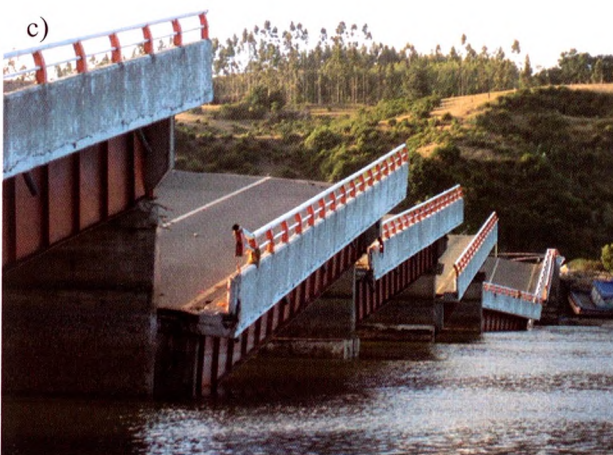
Figure 14 shows the complete collapse of Tubul Bridge. Tubul Bridge is the longest bridge of a series of three bridges located on the Raqui wetland. The other two bridges, Raqui I and Raqui II, have similar structural characteristics, and also suffered complete failure of the embankment accesses, but only Raqui I did not have a deck collapse. The collapsed bridges had small and low reinforced concrete piers initially designed for a timber deck. Timber decks were later on replaced by high steel girders supporting reinforced concrete decks without making substantial structural changes to the piers. Since the bridges are founded on very soft and organic soils, it is believed that a significant seismic amplification took place during the earthquake inducing large displacements. The pier small area where the girders were resting was unable to cope with large and mainly horizontal displacements, although the collapse of the girders was probably eased by vertical displacements as well.

Figure 14: Tubul Bridge a) aerial view showing complete bridge collapse, b) failure of bridge access and c) decks fallen down

Possible solutions to avoid this type of collapse need to be carefully studied owing to the very poor quality of the foundation soil in conjunction with strong seismic events. Soil improvement techniques for the embankments have to reach a deep enough depth into the soft and organic soil. There are methods such as gravel or sand compacted columns; chemical or cement injections can also be considered as well as solutions using geosynthetics. Pier's cap should be enlarged and strengthened to allow girders to move without falling from the pier.

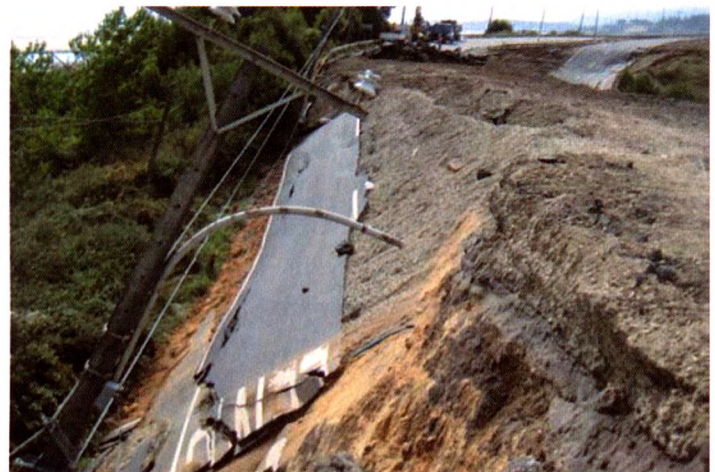
Figure 15 shows the collapse of the road embankment which is the north access to the town of Lota. This 16 m high embankment had originally only one road with two carriageways. In the beginning of the 90s a second road with two carriageways was added next to the original one. Both road embankments were founded on a soft soil, saturated the whole year. For that reason the embankment slid over both side of the road destroying completely the asphalt road and everything around. Even assuming a good quality of compaction of the embankment fill, this did not avoid a highly likely amplification of the seismic waves in the subsoil. Since the subsoil where the embankments were founded corresponds to a saturated, soft and low permeability soil, non dissipated excess pore water pressure generated during the earthquake reduced the undrained shear resistance of this soil. This resulted in the development of failure surfaces over which parts of the embankments slid. It is also believed that the contact surface between the old and newer embankment may have acted as a sliding surface too.

Figure 15: Road embankment collapse at the entrance of the town of Lota
