# Preliminary analysis of the seismic response of bridges during the Chilean 27 February 2010 earthquake

Matías Hube<sup>1</sup>, Hernán Santa María<sup>1</sup> y Felipe Villalobos<sup>2</sup>

*A preliminary analysis of the seismic behaviour of bridges during the February 27th Chilean earthquake is presented in this paper. The traditional characteristics of reinforced concrete Chilean bridges have been changing in the last two decades, especially in concessions roads. Therefore, three different superstructure configurations are indentified. In newer bridges designs, the diaphragm has been eliminated and in some bridges, the reinforced concrete shear key, or stoppers, has been replaced by weaker steel shear keys. Because of the earthquake, 10 relevant public bridges collapsed and 91 concession bridges, which include 52 pedestrian bridges, suffered damage or collapse. The observed damage in selected bridges around Santiago and Concepción are described here. The seismic behaviour of bridges was affected not only by the structural configuration but also by the foundation soil. Findings from this analysis reveal that the strength and stiffness provided by the steel shear keys was inad

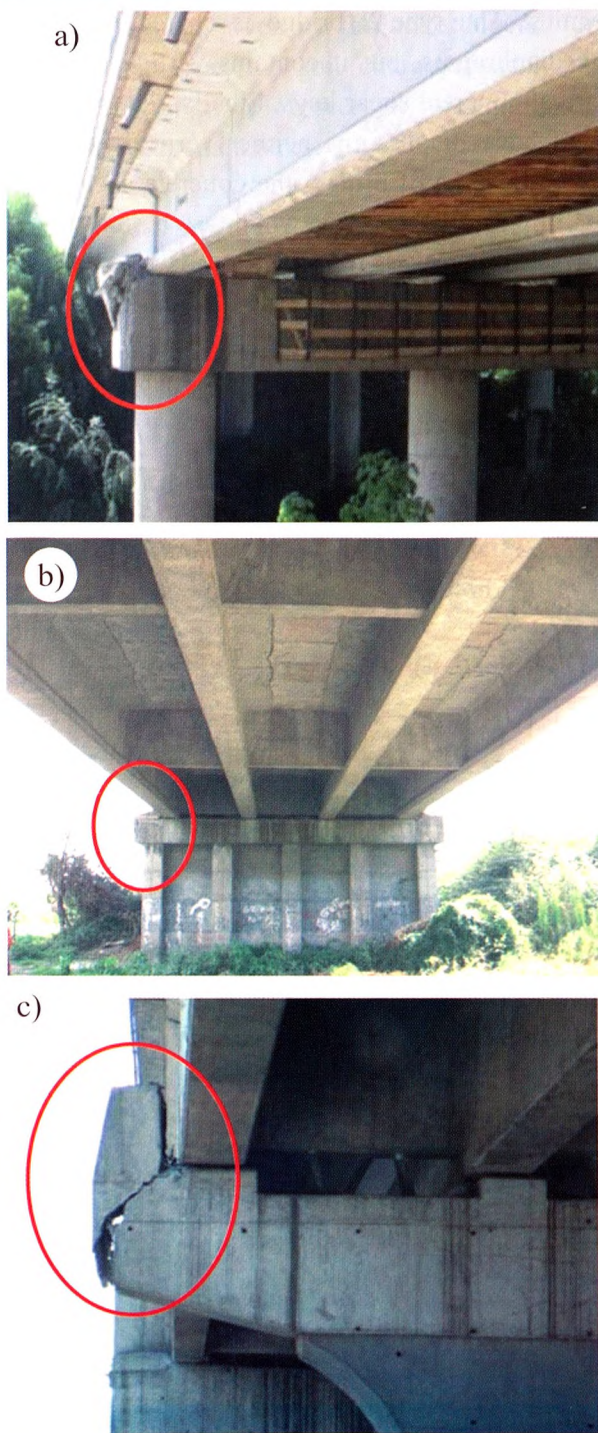
The bridges with better performance and that suffered the less amount of damage were mostly of type 1 configuration. The red ellipse in Figure 3a shows severe damage in the lateral shear key in the west pier of the Costanera Norte bridge over the Mapocho river. The presence of this damage suggests that energy was dissipated in the shear key during the earthquake. However, the bridge deck ended with residual displacement. Figure 3b shows damage in the lateral shear key of the older Lo Gallardo bridge, located in Lolleo and Figure 3c shows extensive damage in the lateral shear key of the Vespucio Norte bridge at Independencia. In the Vespucio Norte bridge, the vertical hold downs ended inclined and the effect of these bars on restraining the bridge collapse in this case may be questionable. From these observations, it can be concluded that the bridges with type 1 configuration behaved relatively good because they did not collapse and because damage was not induced to the piers and abutments.

Figure 3: Damage in bridges of type 1 configuration: a) Costanera Norte, b) Lloleto and c) Vespucio Norte at Independencia

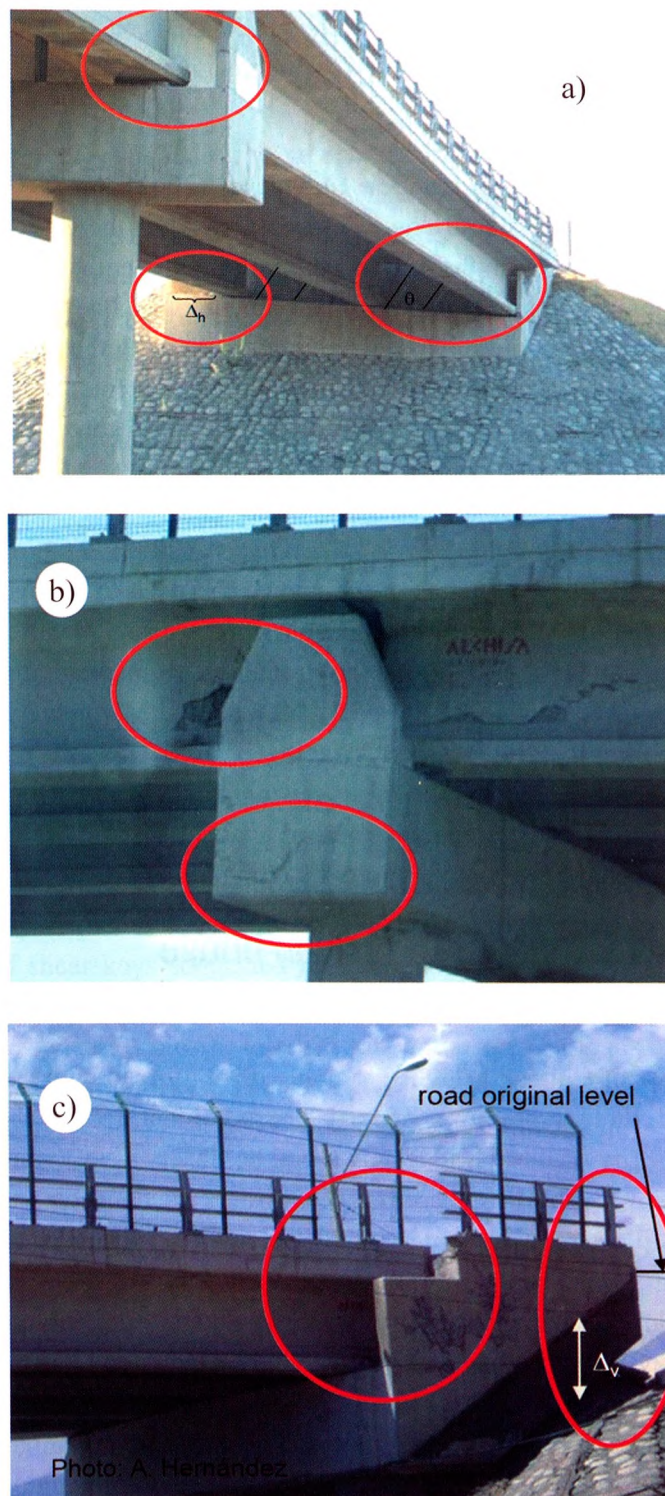
The type 2 bridges, which are characterized by not having diaphragm, suffered larger amount of damage than type 1 bridges. Figures 4a and 4b highlight in red ellipses the damage and displacement of Azufradero underpass located in the South access to Santiago. The girders of this bridge translated and rotated ending with a residual displacement  $\Delta_h$  of about 0.5 m, as shown in Figure 4a. The vertical hold downs ended with a residual angle  $\theta$  of about 45°. For this bridge, the girder impacted the shear key of the central

pier causing damage to the web of the edge girder, as shown in Figure 4b.

The underpass Chada located at the South access to Santiago suffered considerable lateral displacements  $\Delta_h$  of the deck and failure of the embankment connecting to the abutment, a settlement of the embankment  $\Delta_v$  of 60 cm was estimated as highlighted by the ellipse in Figure 4c.

Figure 4: a) and b) Damage in bridge of type 2 configuration, underpass Azufradero, and c) embankment settlement in underpass Chada.

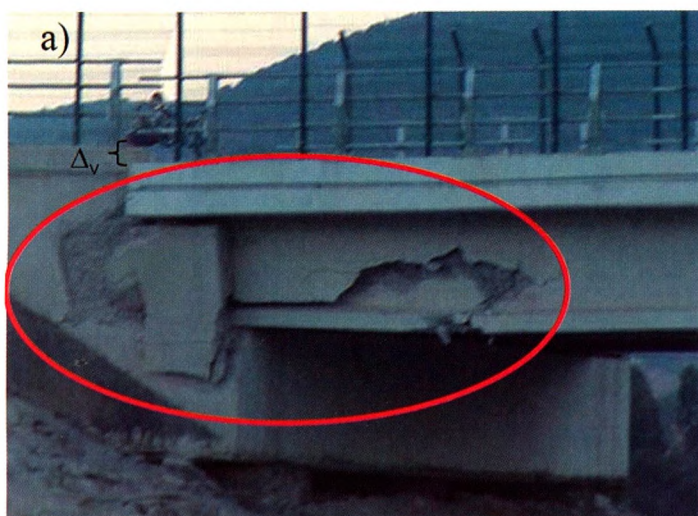
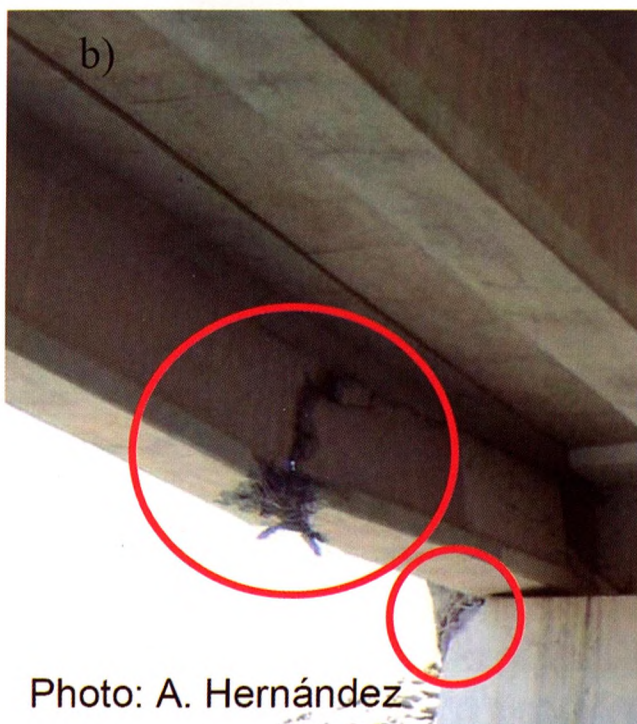
Another type of damage that was observed in type 2 bridge configurations occurred at the girders. Figures 5a and 5b show serious damage in girders of the underpass Chada. Due to the earthquake motion, the girders impacted the shear key, which caused damage in both the girders and the shear key. In fact, Figure 5b shows a complete bending failure of the girder in the weak axis. This type of damage in the girders is not desirable because the girders may not be reparable and a new deck is required to repair the bridge. It is concluded that the use of a diaphragm in this bridge would have distributed the horizontal load of the impact throughout every girder of the deck, minimizing the damage in the edge girder.

Figure 5: Damage in girders of type 2 bridge configuration, underpass Chada, South access to Santiago.

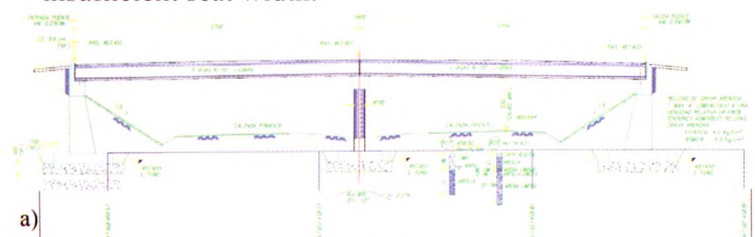
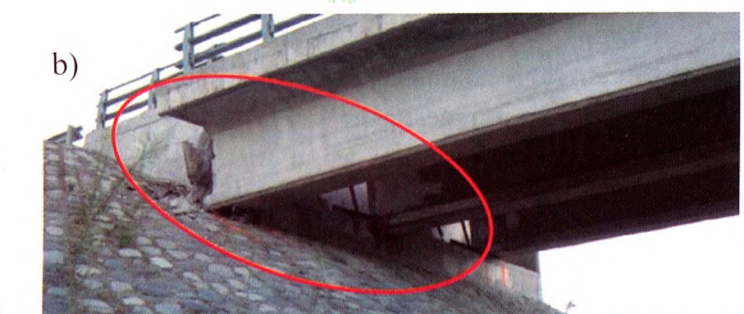
Las Mercedes bridge, of type 2 configuration, is located in bypass Rancagua and it was seriously damaged. A drawing of this bridge is shown Figure 6a. Since the bridge has two spans with a central pier, this cross section is representative of several bridges located in Route 5. In this case, the abutments and pier are founded on shallow footings resting on compacted granular material, gravel and sand with relative densities higher than 80%. The observed damage in this bridge is shown in Figure 6b, where the girders underwent horizontal displacement and they unseated from the abutment. As a result, the lateral shear key was completely destroyed at the abutment, and the vertical hold downs were unable to control the vertical acceleration in order to minimize the lateral displacement. Fortunately, the girders of this bridge were supported by the embankment, allowing traffic under the bridge. The extensive damage observed in this bridge could be explained in part by the subsoil characteristics. Based on the information of the drawing, the foundation subsoil is a saturated and soft material composed mainly of sand and silt. Although the geotechnical exploration only reaches 5 m depth, perhaps this material may even extend deeper. Under this condition, it can be explained in part that the severe lateral and vertical displacements experienced by the bridge deck may be associated to seismic amplification of the saturated and soft subsoil.

Figure 6: Damage in Las Mercedes underpass, bypass Rancagua, route 5.

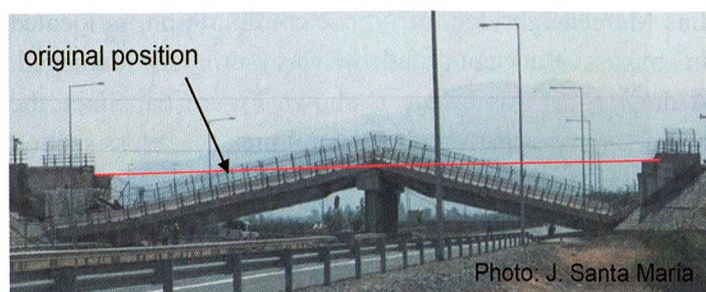
The collapse of Los Pinos underpass, type 2 bridge configuration, is shown in Figure 7. This bridge is located in the South access to Santiago and the deck collapsed in both spans. The shear keys on the abutment failed and the girders fell down due to rotation of the deck and due to insufficient seat width.

Figure 7: Collapse of Los Pinos underpass, South access to Santiago.

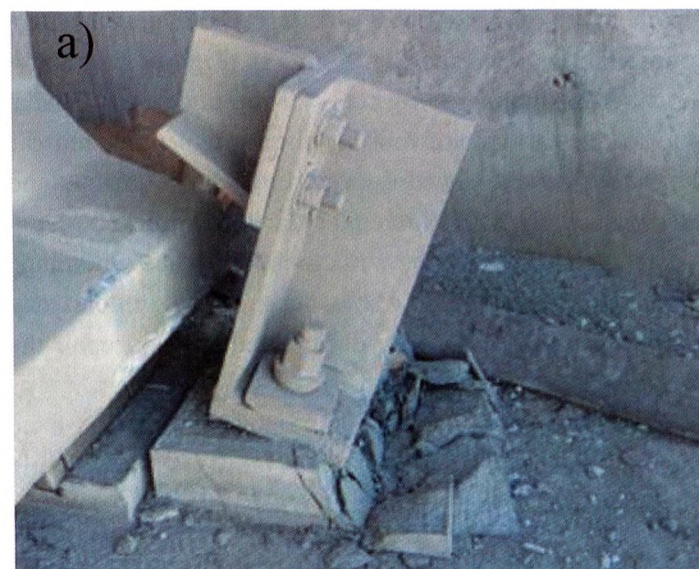
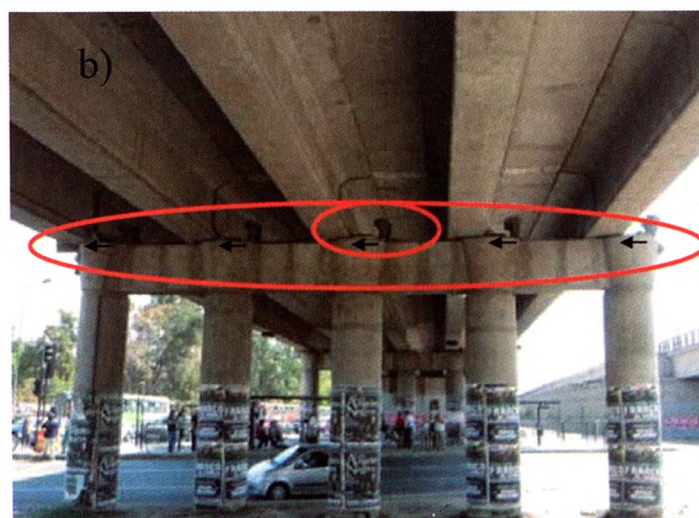
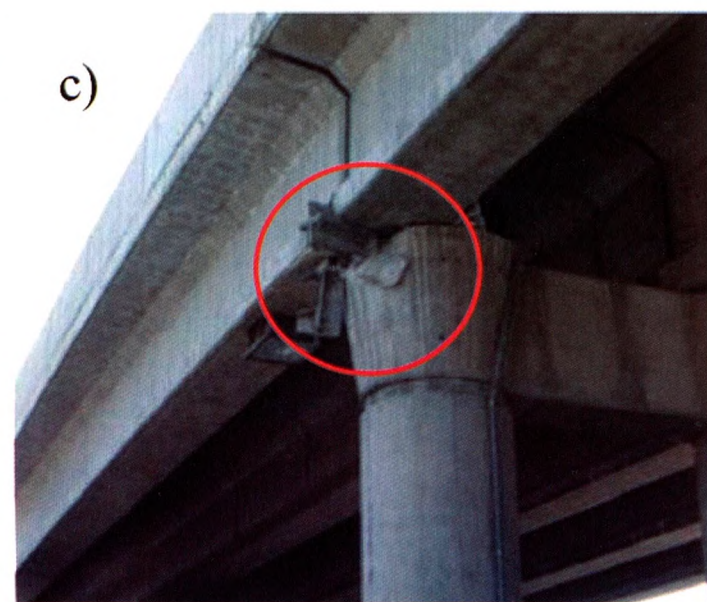
The type 3 bridge configuration, which is characterized by not having diaphragm and by having steel shear keys, was the most damaged type of bridge of the concession roads. The detail of the typical steel shear key, which is also used as a vertical hold down, is shown in Figure 8a. To prevent the lateral displacement of the girder, the steel shear key is connected to the abutment or pier using two bolts. It can be concluded that the lateral stiffness of the shear key is low because it can rotate through an axis parallel to the longitudinal axis of the bridge that pass through the bolts, as shown in Figure 8a. Figure 8b shows the lateral displacement of the bridge deck of Vespucio Norte at Independencia. The lateral displacements of the girders are marked with arrows and red ellipses in Figure 8b. The deck displaced laterally towards the south about 20 cm destroying the shear keys and leaving the deck in a serious risk of collapse, as shown in Figure 8c. Due to this risk, the bridge was shored to allow traffic underneath.

Figure 8: Damage in bridges of type 3 configuration: a) shear key failure detail b) and c) lateral displacement of girders in Vespucio Norte at Independencia.

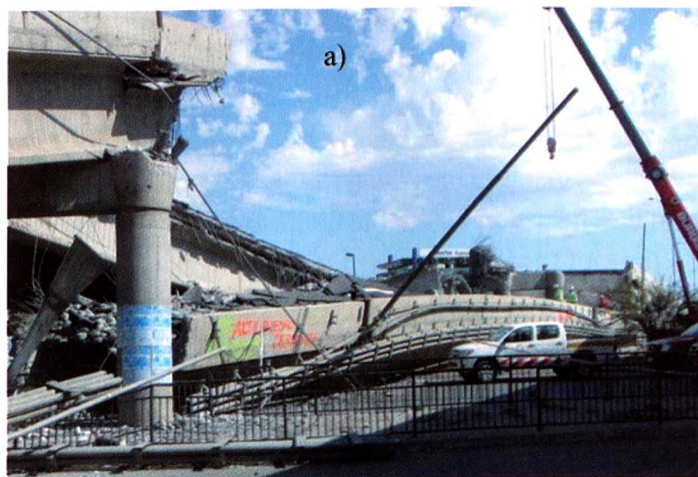
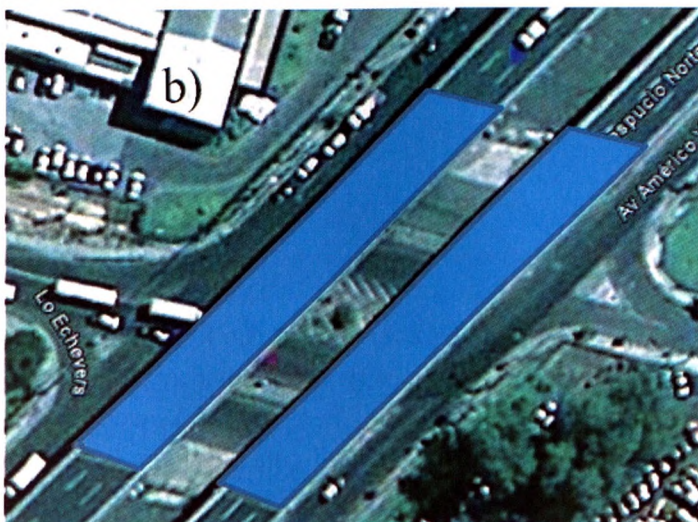
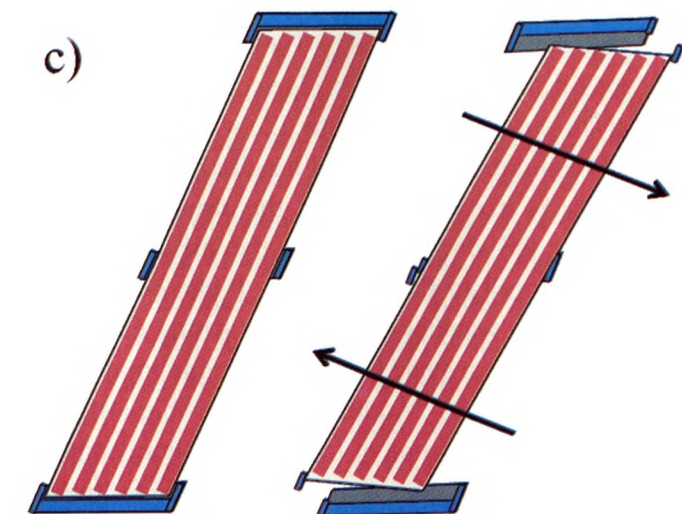
The bridges at Lo Echevers and Miraflores in Vespucio Norte, of type 3 configuration, collapsed both in a similar catastrophic manner. At Lo Echevers only the east bound of the overpass failed, whereas both bounds failed at the overpass Miraflores. The collapse of the east bound of Lo Echevers overpass is shown in Figure 9a. The collapse of this bridge was caused by the failure of the lateral shear keys and the rotation of the deck as shown in Figure 9c. The cause of the rotation of the deck is attributed to the angle of skew, which is about  $33^\circ$  in this bridge (Figure 9b). To reduce excessive rotation of the deck in a  $50^\circ$  skewed bridge, Watanabe and Kawashima (2004) studied three different cable restrainers as possible solutions based on analysis of rotation mechanisms. Finally, the extensive damage in Lo Echevers and Miraflores could also be attributed to the colic soil deposits which are much softer than the gravel deposits usually found in others areas of Santiago.

Figure 9: Lo Echevers junction a) bridge collapse, b) plan of skewed bridges and c) deck rotation

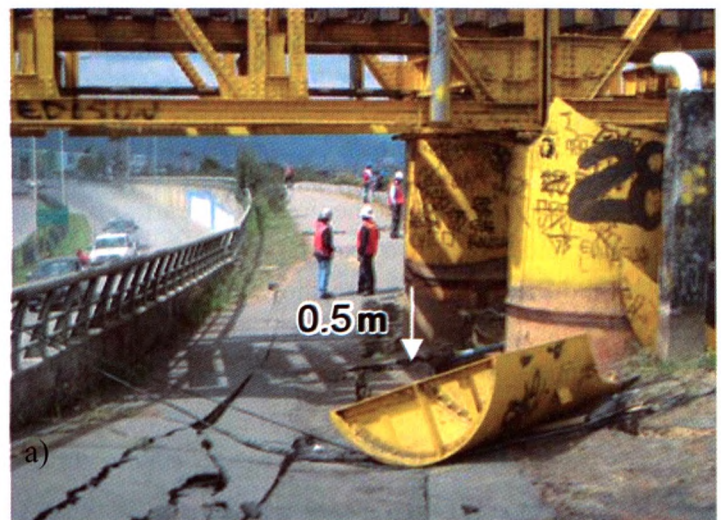
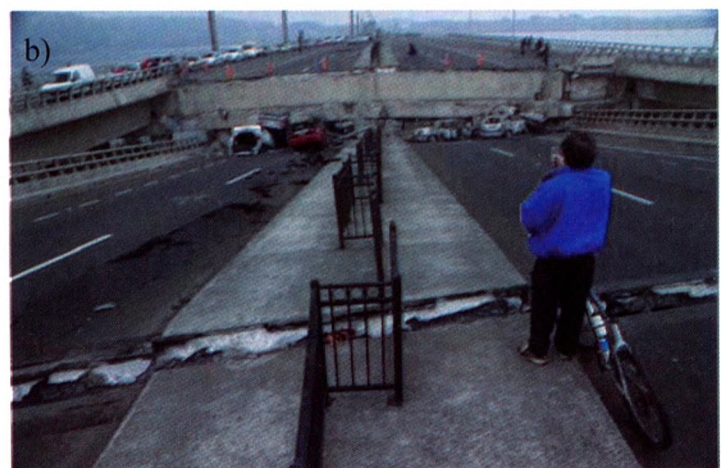
amount of damaged was the railway bridge, which was built in 1889. This bridge is structured with steel trusses and is founded on very deep laminated steel piles. The major problem of this bridge was the lack of rail alignment due to settlements and lateral displacements. This alignment was very sensible to aftershocks, which allowed the train service only after five months of repairs. Additionally, damage occurred in the abutment of the Concepción side caused by the displacements of a retaining structure of the road passing under the bridge. Figure 10a shows that the pedestrian path under the bridge settled about 0.5 m because of the lateral displacement and differential settlement (about 0.2 m) of the road retaining wall.

Figure 10: a) Abutment settlement and lateral displacement in Concepción railway bridge and b) collapse in the access to the Llacolén bridge in the Concepción side

The Llacolén bridge, built in 1999, is the newest bridge over the Bío Bío River. Beyond the Concepción side abutment, each pier is founded on a transversal row of six piles of 1.2 m in diameter. The bridge did not have diaphragms connecting the girders (type 2 configuration). The damage in Llacolén bridge is shown in Figure 10b,

where the girders unseated from the piers at the Concepción side. In spite of this collapse, traffic could still be established by connecting the bridge deck with a lateral access from a perpendicular road. The other symmetric access was not functional for cars due to gaps between decks of up to 30 cm. Since this was the only available bridge to cross the Bío Bío river, a prefabricated temporary steel bridge was installed a few weeks later at the Concepción side to make possible a straight cross onto the bridge. The temporary steel bridge lasted about five months until the final repair.

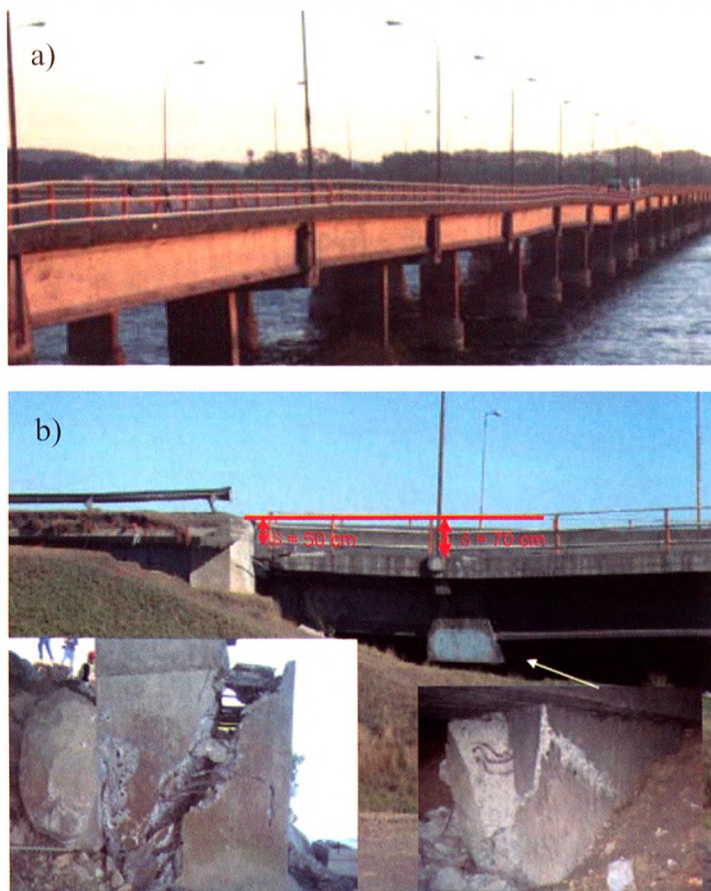
The Juan Pablo II Bridge suffered serious damage due to foundation differential settlements and structural failure of some piers and abutment. This bridge had been used since 1974 and was designed by the English company E.W.H. Gifford & Partners. This bridge, of type I configuration, is structured with piers having two columns founded on piles no more than 15 m deep. At the time of the earthquake, the bridge was under repair to fix a hole that passed through the slab of the deck. Figure 11a shows the bridge from the Concepción side, where differential settlements and resulting unevenness of the bridge deck can be observed. These

differential settlements induced rotation of the piers causing transversal and longitudinal unevenness in the bridge superstructure. It may be concluded that the diaphragm of this bridge helped to keep the integrity and avoid unseating, which was not the case of the Llacolén bridge. The differential settlement, which occurred in four sections of the bridge, can be explained by the occurrence of soil liquefaction (GEER 2010). Additionally, in the Concepción side, shear failures were observed in reinforced concrete columns of the cap beams. These pier shear failures induced structural settlements of the bridge deck of about 50 cm to 70 cm, as shown in Figure 11b. In spite of the severe damage of this bridge, it was open for pedestrians, bicycles, motorcycles and even a few cars. However the traffic had to deal with the uneven surface when crossing the bridge.

Figure 11: Juan Pablo II Bridge showing a) unevenness due to pier differential settlements and b) shear failure in reinforced concrete piers

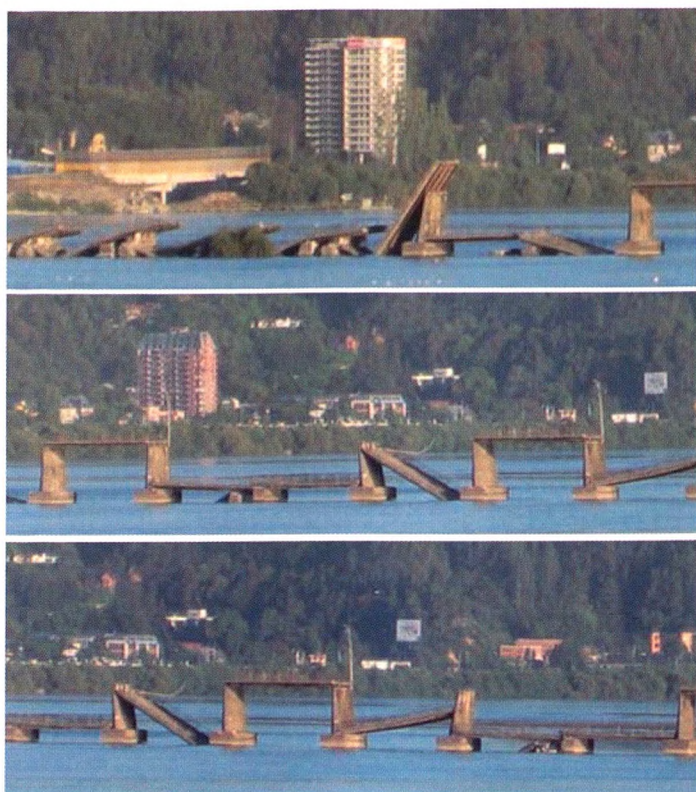
Lastly, the “old” Bío Bío Bridge totally collapsed during the 2010 earthquake. It was built during the 1930’s, but was open to traffic in the early 1940’s. It was the first bridge for car vehicles over the Bío Bío River. The bridge length was 1650 m over the river and it had an extension of 220 m over a floodable area. The bridge decks were simply supported on hollow reinforced concrete piers by means of steel beams and the piers were founded on wood piles. According to Steinbrugge and Flores (1963) two spans of the bridge collapsed during 21<sup>st</sup> May 1960 and three spans collapsed during the 22<sup>nd</sup> May 1960 earthquake, on the Concepción side. Parts of the bridge collapse after the 2010 earthquake are shown in Figure 12, where many decks, not well restrained to lateral and longitudinal movements, fell down. As a consequence of the strong shaking, an initial deck fell down damaging the pier and causing the adjacent deck to fail and so on. It can be concluded that this bridge was not designed for strong earthquakes because of the inadequate lateral and longitudinal restraint of the bridge decks. Additionally, possible effects of liquefaction, amplification or foundation failure could also have occurred at this time, as it was suggested for the 1960 earthquake by Steinbrugge and Flores (1963).

Figure 12: Sections collapsed of the Bío Bío Old Bridge
