# Seismic response of the Convento Viejo earth dam during the February 27<sup>TH</sup> 2010 Chile earthquake

José Campaña, Luis Valenzuela and Edgar Bard

ARCADIS Chile, Eliodoro Yañez 1893, Providencia, Santiago, Chile, jose.campana@arcadis.cl, luis.valenzuela@arcadis.cl, edgar.bard@arcadis.cl

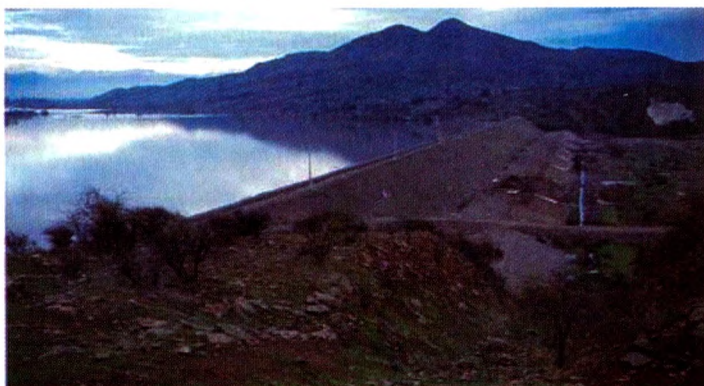
Figure 1: Convento Viejo dam operating only with the cofferdam (ICOLD, 1996)

The construction project started in 1973, but work was halted in 1975 due to financial problems. The construction was resumed in the period between 1978 and 1979, but once again was stopped due to changes in financing policies implemented by the Chilean government. Regarding the earth zoned dam the works that were completed in the above-stated periods included a slurry wall, the cofferdam of the earth dam, water diversion and water delivery tunnels, emergency spillway, and the excavation of the abutments of the earth dam. Figure 1 shows the state of the works by the mid 1990's and Figure 2 shows the

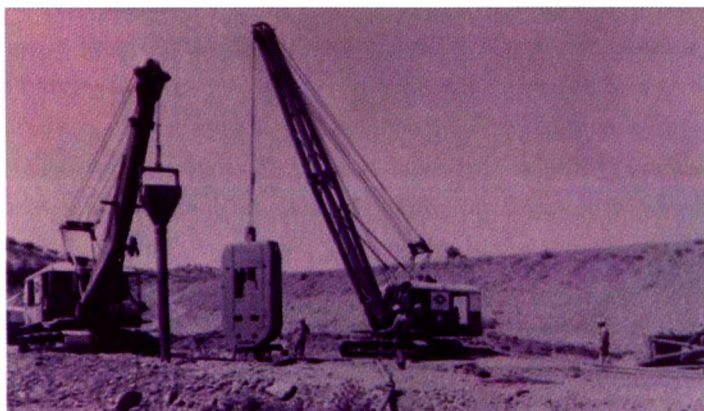
Figure 2: Construction of the slurry wall (Bachy, around 1974)

construction process for the slurry wall, which reached a depth of 55 m, and a length of 500 m using panels 7.2 m wide. The cofferdam and the slurry wall allowed the formation of a smaller reservoir that was in operation until the dam completion in 2008. Between years 2000 and 2002, the engineering studies were updated and the designs modified in order to accommodate the existing conditions at that time. The construction of the earth and concrete dams was initiated in 2006 and finalized in 2008. Figure 3 shows the present condition of the embankment dam.

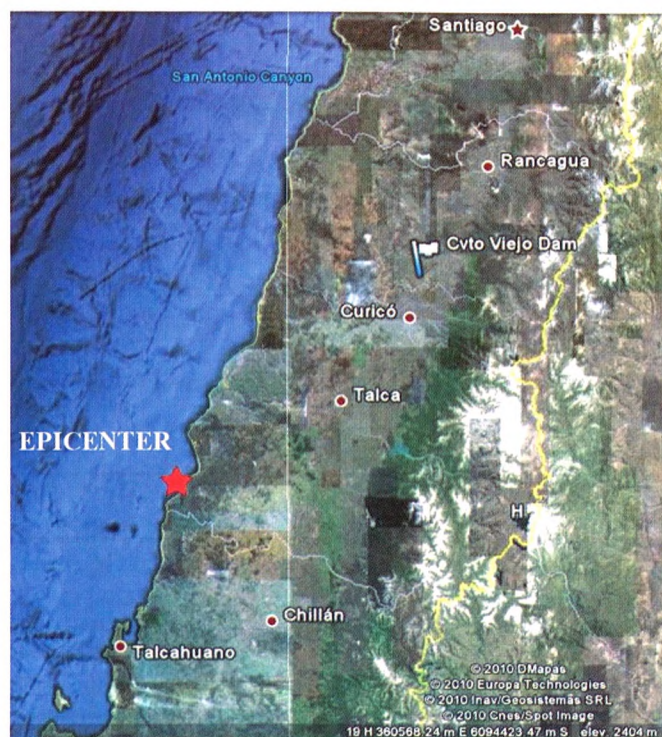
Figure 7: Location of the epicenter and Convento Viejo Dam

The epicenter of this earthquake (EQ) was located in the ocean in front of the town of Cobquecura at a depth of 47.4 km below the earth crust. Figure 7 shows the locations of the epicenter and of the Convento Viejo Dam. Figure 8 shows the estimated Mercalli intensities in the central and south regions of the country (Astroza *et al.*, 2010). The long duration of the earthquake, the high content of long period waves and maximum vertical accelerations similar to the maximum horizontal accelerations (Table 4) are the main earthquake’s characteristics that may explain many of the observed damages. Another important characteristic of this earthquake was the high magnitude of the numerous aftershocks that occurred in the days that followed the main earthquake. In fact, until May 3<sup>rd</sup> some 17 shocks with magnitudes over 6.0 Richter occurred. Special mention has to be given to the particularly strong earthquake of March 11<sup>th</sup>, initially considered as an aftershock but afterwards recognized as a new earthquake with an epicenter 9 km inland and some 150 km North of the February 27<sup>th</sup> epicenter. This earthquake had a magnitude Richter of 6.9 and after a few minutes was followed by two aftershocks of 6.7 and 6.0.

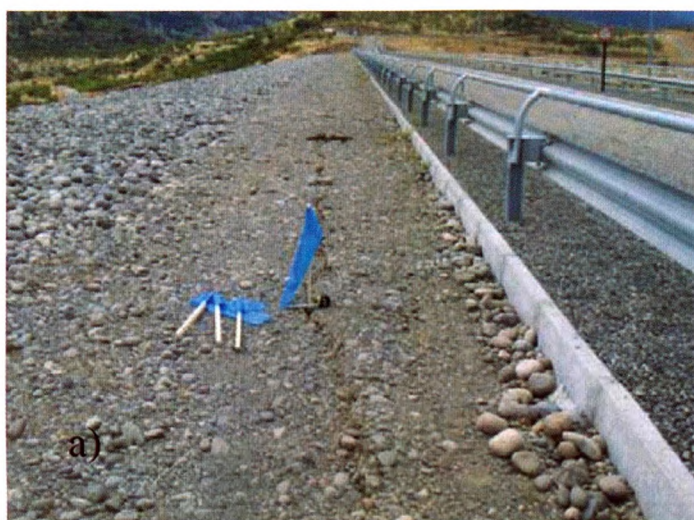
Figure 11: Cracks observed at the crest of the earth dam: a) downstream slope, b) upstream slope.

In general, the behavior of the earth dam was quite satisfactory; there were no external signs that accused significant problems. Superficial cracks were detected at the dam crest in the area where greater settlements were to be expected, according to the dynamic analysis carried out during the design stage. Nevertheless, two of the Casagrande-type piezometers presented a behavior that required a detailed analysis as well as a continuous monitoring of their evolution for at least a month.
