# Description and analysis of geotechnical aspects associated to the large 2010 Chile earthquake

Ramón Verdugo<sup>1</sup>, Felipe Villalobos<sup>2</sup>, Susumu Yasuda<sup>3</sup>, Kazuo Konagai<sup>4</sup>, Takahiro Sugano<sup>5</sup>, Mitsu Okamura<sup>6</sup>, Tetsuo Tobita<sup>7</sup> and Andrés Torres<sup>1</sup>

*A description of the strong 27 February 2010 seismic event occurred in centre and south of Chile is presented. Main geology and geotechnical conditions of selected sites are described. The study focuses mainly, but not only, on the liquefaction phenomenon which affected housing developments in Concepción, Hualpén and San Pedro de la Paz. The earthquake occurred at the end of the summer, therefore ground dry conditions prevailed. However, grounds near to water bodies were still saturated, mainly in places which were previously part of swamps and wetlands. In some of these places the replacement of soft and loose soils for compacted sand fills was not enough to avoid the occurrence of liquefaction. It is suggested to consider other techniques of soil improvement or deeper foundations when the subsoil has low shear strength and hence potentially liquefiable. An examp

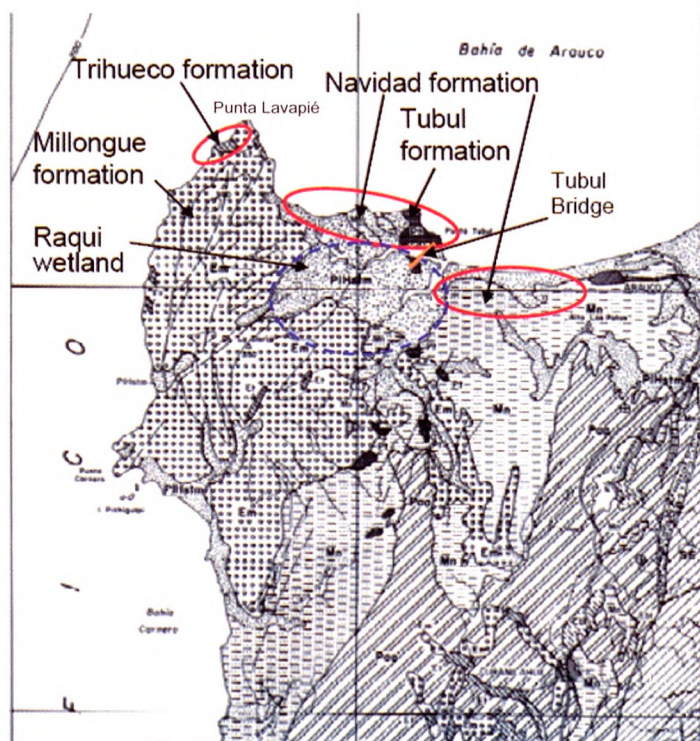
Different was the case of cliffs 100 m high in average found in the Arauco Peninsula, where large amount of ground slid. Figure 12 shows a geologic map of the Arauco Peninsula, highlighting the areas where landslides were observed. The material of these cliffs

Figure 12: Geologic map of the Arauco Peninsula, showing in red ellipses landslide areas (Ferraris and Bonilla, 1980)
